Accidental migration of a guidewire during femoral venous catheterization -A case report-

We report a case of a 60-year-old woman, which presented severe burns from a gas cylinder explosion in domestic accident. The burned body surface was about 35% with second and third degree burns. To ensure intravenous fluid resuscitation, a central femoral venous catheterization was decided, but during the procedure, the guidewire was pushed into the femoral vein by physician. The pelvic x-ray showed the guidewire in the femoral vein. It was successfully surgically extracted from right common iliac vein. This complication is rare and avoidable. Factors that contribute to a guidewire loss into circulation include operator inexperience, lack of supervision and inattention. The prevention is the best treatment and simulation training can significantly help to reduce this complication.

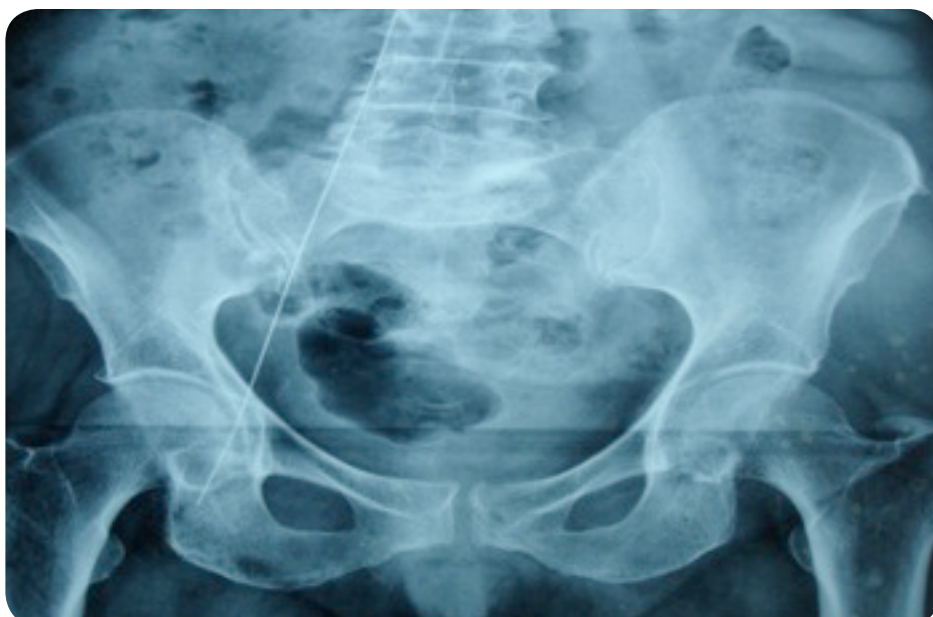
Figure 1. Pelvic x-ray showing the guidewire in the femoral vein.

alternative site for venous access, a central venous catheterization was decided. An emergency physician decided to cannulate the right femoral vein, area where the surface of the skin remains intact. After cleaning and draping, an initial cannulation was done with needle attached to a syringe. Following this the dilator and the guidewire were introduced. Unfortunately, by inattention, the guidewire was pushed into the femoral vein by operator. The procedure was immediately stopped and an urgent pelvic x-ray was done, it showed the guidewire in the femoral vein (**Fig. 1**). The vascular surgeon decided to remove the wire by open surgery in the operating room. This procedure was performed under general anesthesia. The average peroperative blood pressure was 135/65 mmHg and heart rate 130 bpm. During surgery, which lasted for 60 min, the patient received 1500 ml normal saline solution by intravenous infusion. A venotomy revealed migration of guidewire to the right common iliac vein. It was successfully extracted. The patient was extubated at the end of operation, and then transferred to the intensive care unit. She was discharged from the hospital 18 days later in good condition.

In conclusion, hence recommendations are to perform the procedure by an experienced operator or under supervision, guidewire not to be pushed too far and while threading the catheter over guidewire, guidewire should at all the times be held by other hand, catheter should be rail-roaded over the guidewire into the vein and not pushing the catheter and guidewire together. Routine use of ultrasound and fluoroscope guidance throughout the procedure can be of great help in avoiding such complications. Finally the medical simulation is a useful tool for training physicians and can assess competence; it can reduce complications related to the central venous catheterization by Seldinger technique [18].
